# Manhole Inspection Summary

Manhole # S39SS\_002MH

Insp Date: **4/9/07 10:35 AM**

**Location** Address: **2701 LOCH RAVEN RD** Cross Street: **EXETER HALL AVE**

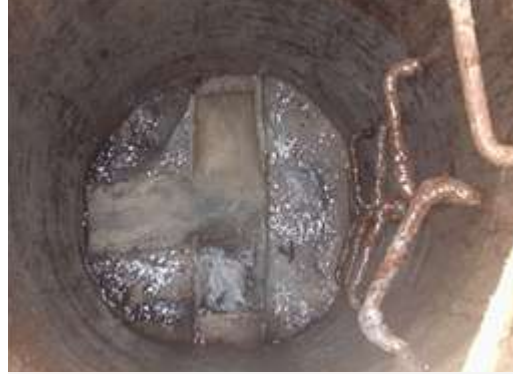
Top View

Corbel infiltration. Corroded steps. Bench debris.

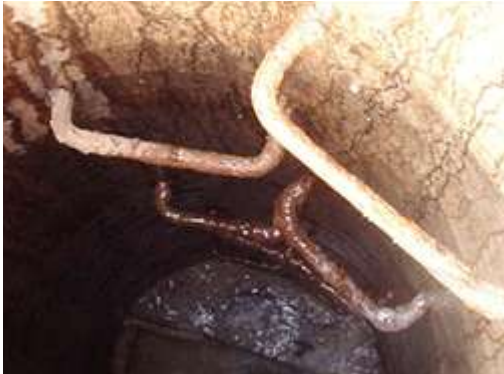
Defect

CORRODED STEPS

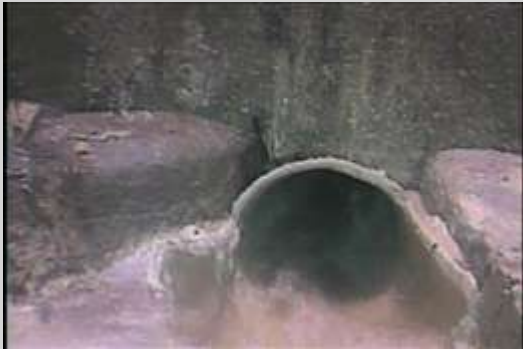
### 12 in. Circular Gravity Sewer Pipe Out @ 12 O'Clock

Invert Depth: **16.83** (ft.) Flow Characteristics: **Fast**

Infiltration: **None** Pipe Seal Cond: **Unknown**

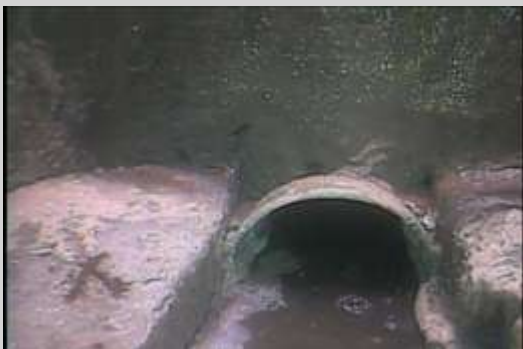
### 12 in. Circular Gravity Sewer Pipe In @ 6 O'Clock

Invert Depth: **16.64** (ft.) Flow Characteristics: **Slow**

Infiltration: **None** Pipe Seal Cond: **Unknown**

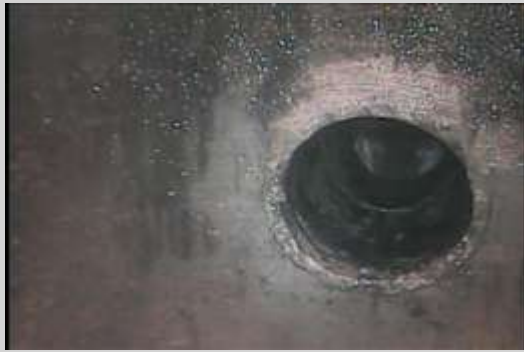
Pipe In @ 9 O'Clock

Invert Depth: **14.28** (ft.) Flow Characteristics: **Fast**

Infiltration: **None** Pipe Seal Cond: **Unknown**

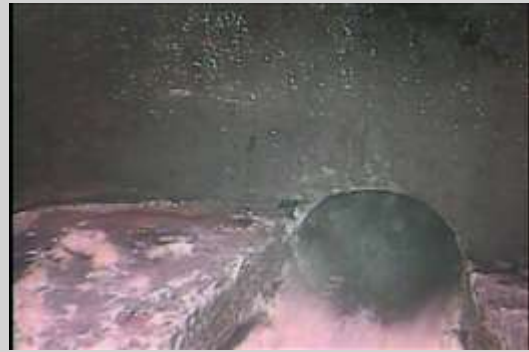
Drop In @ 9 O'Clock

Drop: **Outside** Rod and Bar

Angled: **Yes** Reading: **15.07** (ft.)

Inv Depth: **16.07** (ft.)

Drop Condition: **Open**
